Inspection Report

Minerals Regulatory Program

Mine Name: Promontory Point West
Operator Name: Kerry's Inc

Permit number: S0030057
Inspection Date: 07/18/2006
Time: Morning

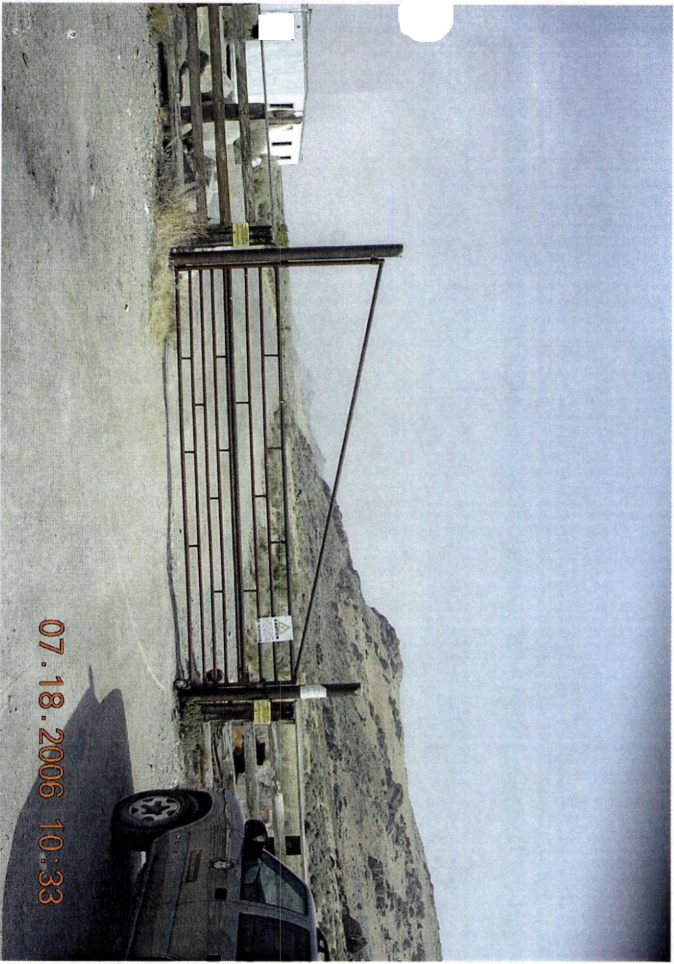
07.18.2006 10:33

Unable to access site due to locked gate.
